POLITECNICO DI BARI

Doctor of Philosophy in Environmental and Building Risk and Development

**Innovative methods and techniques for diagnostics and monitoring of architectural heritage, through digital image processing and machine learning approaches**

Cover image: elaborated 3D model of the north tower, Bashtova Fortress (Albania)

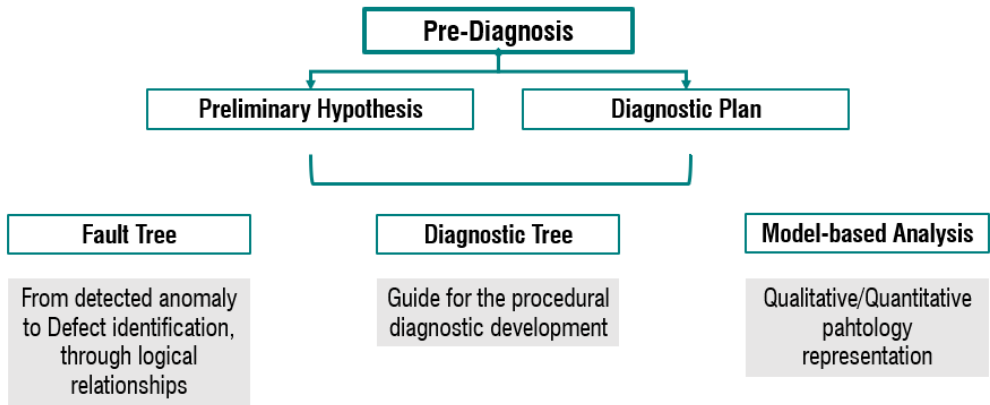
Fig. 3 – Pre-diagnosis: instruments (image elaborated by the author, based on [5])

Given the complexity of the problem, there are some instruments which constitute a support or a guide for the professionals, to organize and orient the diagnostic investigations (fault-tree, diagnostic tree or model-based analysis), as illustrated in Fig. 3.

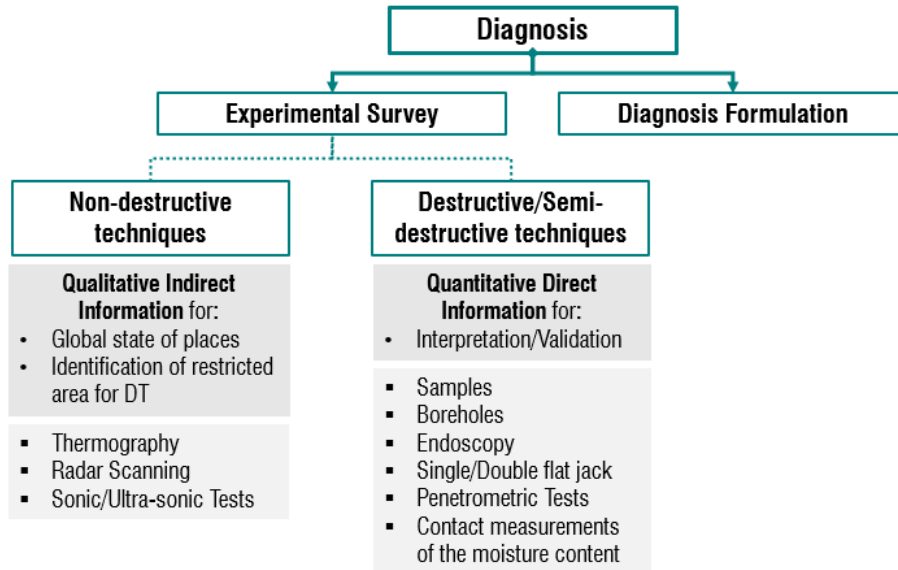
Fig. 4 – Diagnosis (image elaborated by the author, based on [5])

The third macro-area concern the diagnosis of the detected anomalies, the identification of their causes and the planning of adequate interventions for the requalification process (Fig. 4). In this phase quantitative and qualitative destructive or non-destructive analyses, and experimental investigation (samples and tests) are performed, to obtain a deeper understanding of the detected phenomena and formulate a diagnosis. There are a variety of techniques, depending on the kind of anomalies to analyse. The outcomes are represented by a final formulation of a diagnosis, retrieved from the combination of the outputs of investigation tests, as projected in the pre-diagnosis phase, and the prior knowledge acquired along the previous phases[2].

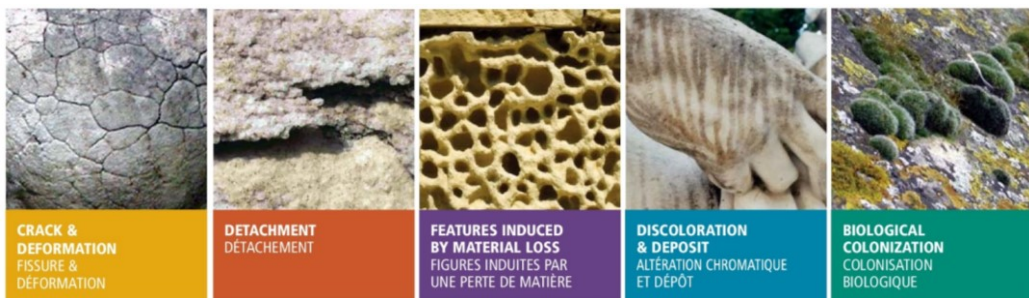
Fig. 8 – Five macro-areas of surface alteration, identified by ICOMOS ([28])

The international ICOMOS 'Illustrated glossary on stone deterioration patterns' (2008) provides a common language, in order to recognize and compare degradation patterns. It supplies a qualitative differentiation in five categories of decay phenomena (cracks and deformation, detachment, features induced by material loss, discoloration and deposits, biological colonization), which is further articulated in sub-classes containing all the peculiar alterations (Fig. 8) [28].

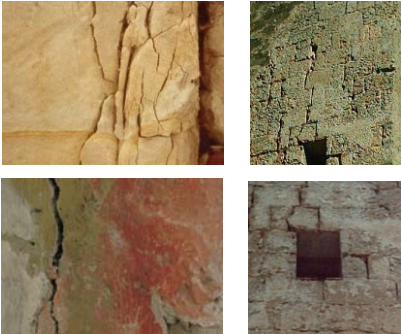
ALTERATION	STANDARD DEFINITION	GRAPHICAL REPRESENTATION
<p><b>Crack/ Fratturazione o fessurazione</b></p>	<p><b>DEFINITION:</b> Individual fissure, clearly visible by the naked eye, resulting from separation of one part from another.  <b>CAUSES:</b> Cracking may be due to weathering, flaws in the stone, static problems, rusting dowels, vibrations caused by earth tremors.  <b>SUB-TYPES:</b> fracture, star crack, hair crack, cracquele, splitting</p>

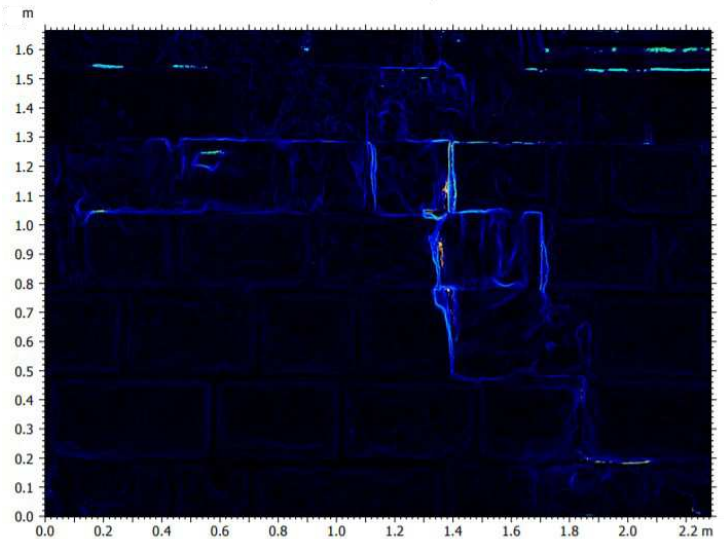
Fig. 18 – Example of application of edge-extraction on a masonry surface

The output of the gradient filter application is a binarized surface point cloud, where points located in areas of maximum discontinuity are distinguished from the remaining points (Fig. 18). As a matter of fact, the distribution of gradient values and its magnitude on the surface is useful to determine points where the slopes vary gradually and points where they vary more rapidly (edges).

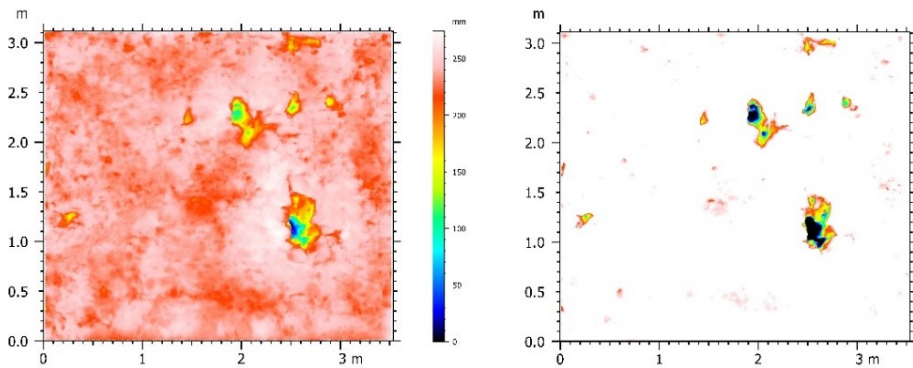
Fig. 19 - 3D representation of a restricted masonry wall area, on which thresholding have been applied [4].

To achieve surface segmentation, another alternative is the binarization of the surface, which, analogously to the thresholding, apply a threshold to a surface, producing a binarized image as output, in which the areas above the threshold (foreground) are distinguished from the areas below the threshold (background).

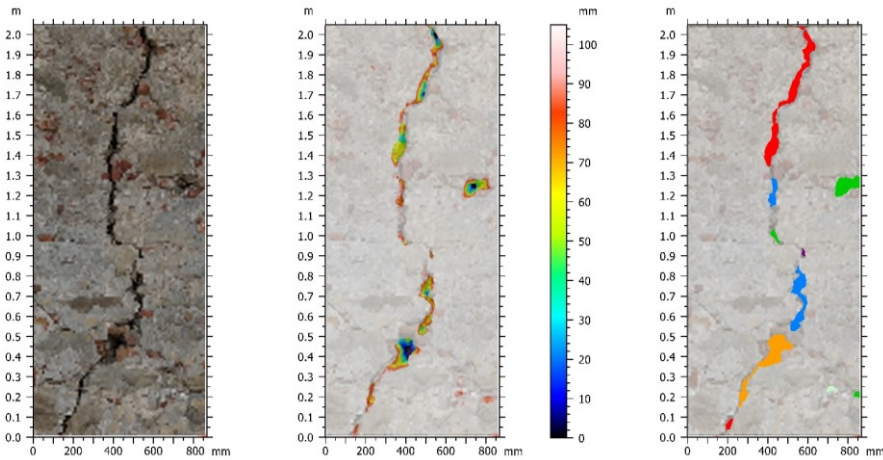
Fig. 20 - From left to right: point cloud of a masonry wall; application of the threshold operator; segmentation of the identified areas into regions (indicated by different colours).

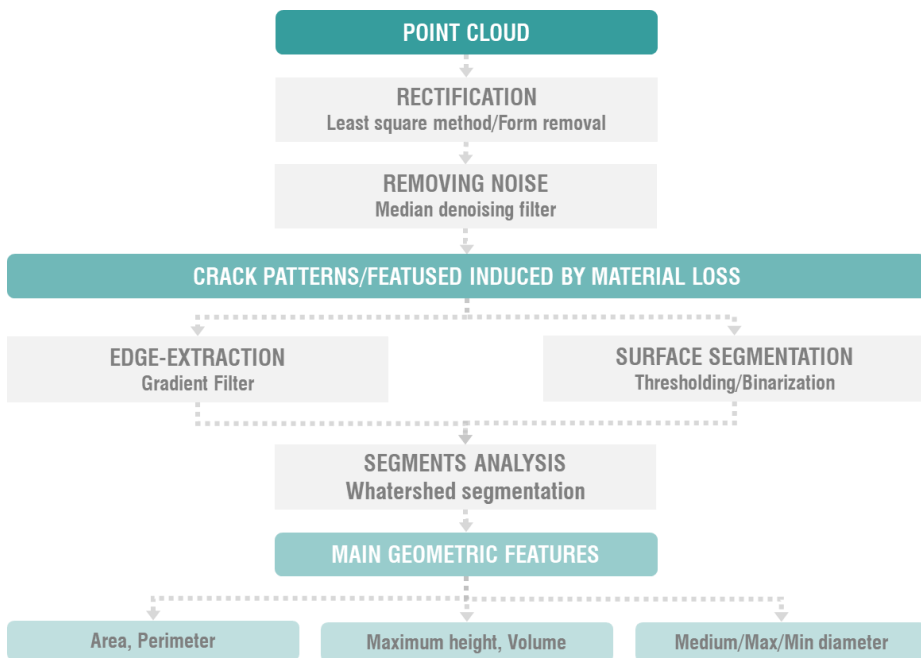
Fig. 21 - Flow chart illustrating a protocol, for detecting and measuring cracks or features induced by material loss, starting from a point cloud (based on [4]).

In Fig. 21, a graphical representation of the image processing workflow is proposed.

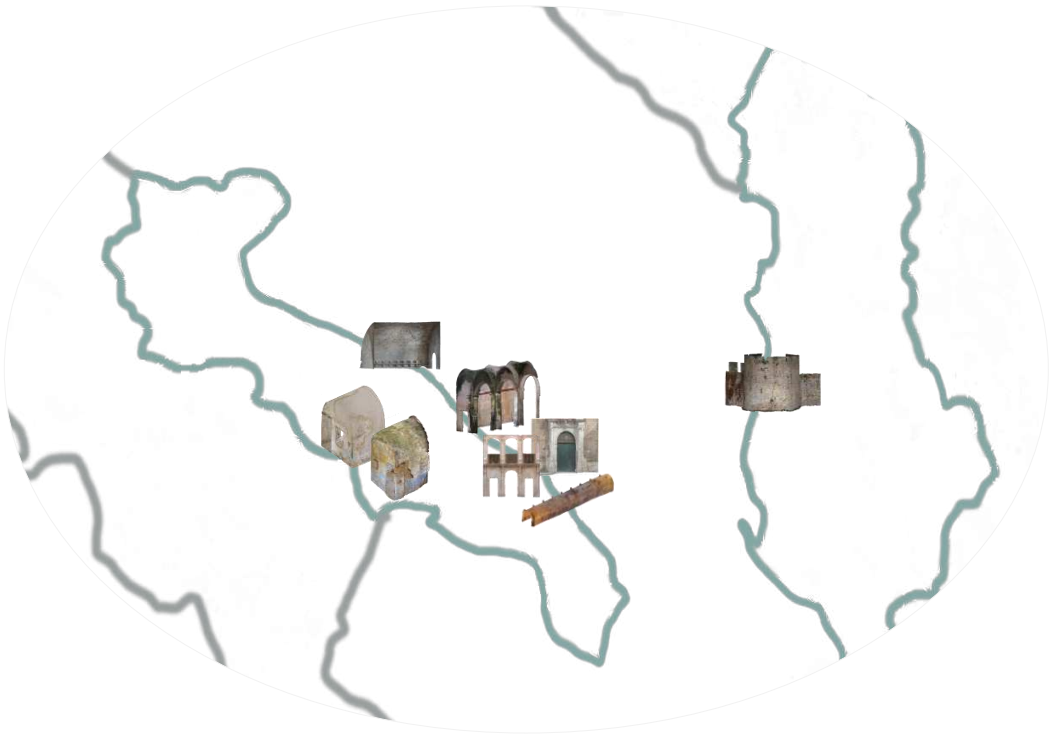
The proposed procedures were applied and tested on a variety of case studies, belonging to the territorial (regional or international) cultural heritage, chosen according to some criteria:

- Age of construction (from the I century BC, to the XVIII century AC);
- Building type (residential palace, ex-convent, medieval fortress, church, archaeological area);
- Surface materials (smooth or ashlar limestone, tuff, brick, plaster);
- Architectural environments and related shapes (façade, pillar, column, vault, wall, cloister, cryptoporticus);
- Decay phenomena (static instabilities: crack patterns, displacements, deformation; surface deterioration: erosion, alveolization, lacks; colour-based alterations: moisture patterns, chromatic alterations, spots, deposits).

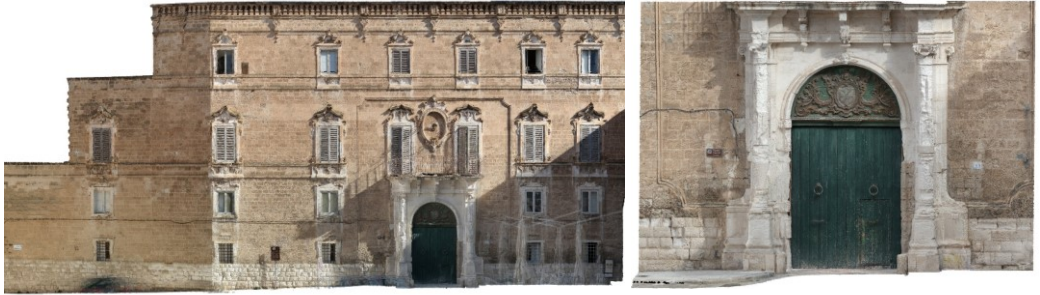
Fig. 33 - High-resolution texturized polygonal mesh of the main façade, with a zoom on the portal [4],[16].

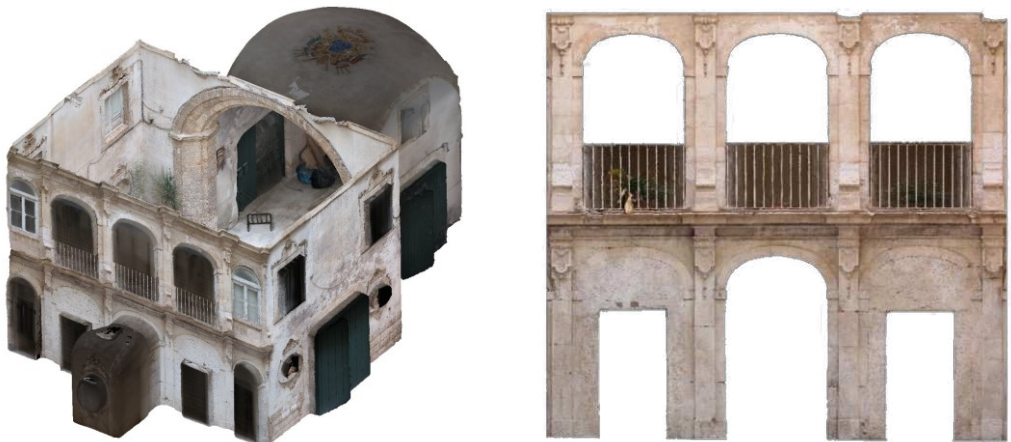
Fig. 34 – High-resolution texturized polygonal mesh of the internal courtyard, with a focus on the lower part of the staircase façade [4],[16].

Through the portal, it is possible to reach an atrium or internal courtyard (Fig. 34), where there is the access to the stone staircases, leading to the upper floors (three apartments) and to the solar roof. On the ground floor, near to the main door, there were stalls for horses, the coach depots and the stocks [240].

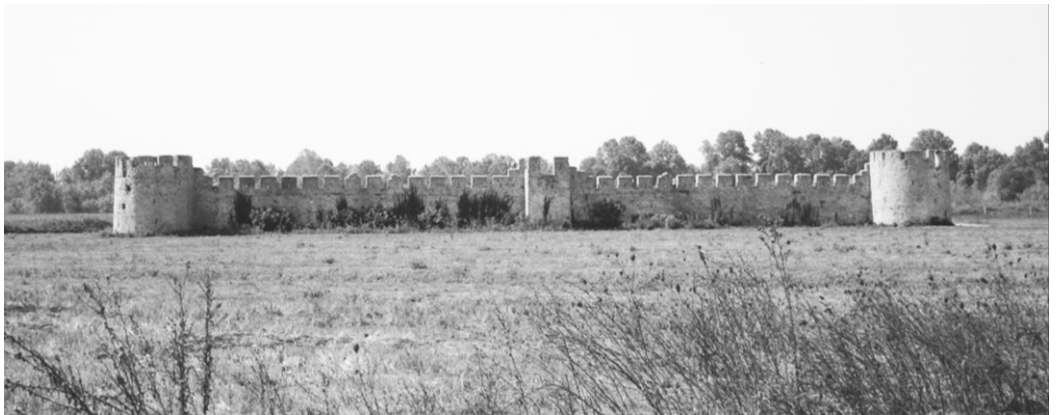
Fig. 35 – North-east façade

It is an architecture made of local sandstone, with a quadrangular development, perimetral walls, three entrances and four towers at the corners, of which only two still exist. The overall dimensions are 60 x 90 m in plan, with a walls' thickness around one metre, and a towers height of about 12 metres. The western wall was reconstructed during the XVIII century. Except for the western tower, the perimetral walls and the towers still preserve a global integrity, guaranteed also by interventions in respect of the original materials and assets, also in the castle proximity [143].

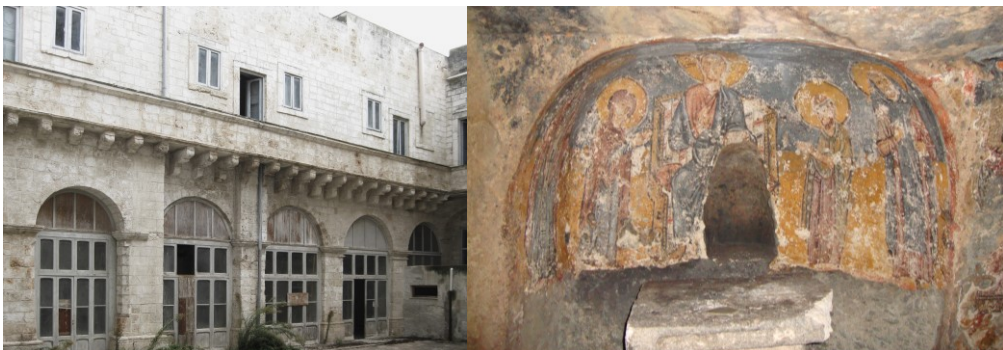
Fig. 44 – Interior façade toward the cloister; wall-fresco of the Crypt.

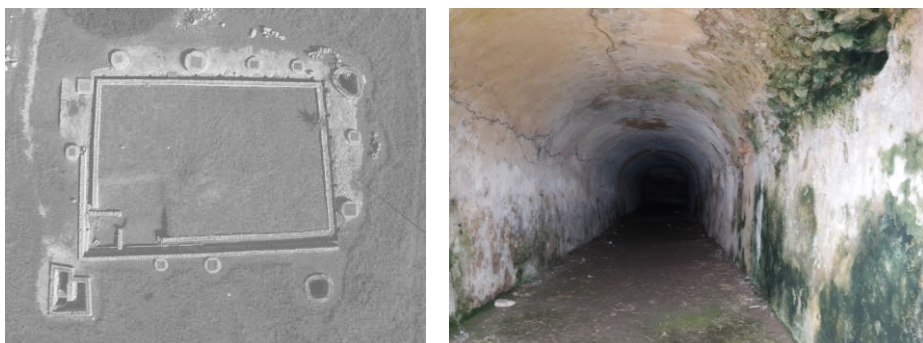
The Cryptoporticus is an underground structure, dating back to the I century B.C, with four arms of different lengths, partially excavated in the rock and partially realized with opus incertum (cement, stone and mortar), covered with plastered barrel vaults (Fig. 48). On the inner sides of the arms, openings are located at regular distances; two pairs of entrances are placed on the longer side. The structure can be interpreted as covered ambulatory or as deposit for cereals (horreum) [81].

Fig. 48 – Cryptoporticus: top view, interior view.

The whole structure of the Cryptoporticus is considerably affected by the presence of water and the lack of air and light, which led to extended humidity patterns. For this reason, the south-west arm of the structure was analysed in detail, with machine learning techniques.

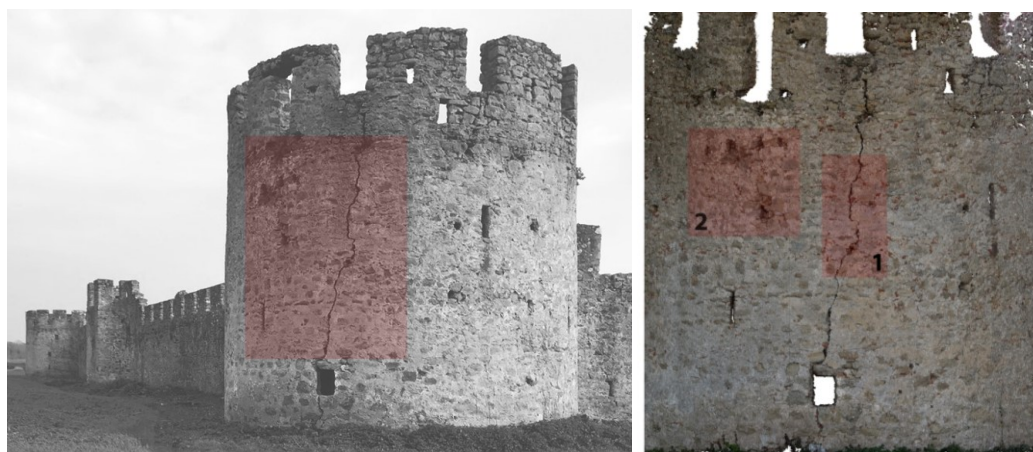
Fig. 52 - North tower of the Fortress of Basthovë. with the indication of samples used for the application of the methodology.

The approach illustrated in Section 5.1.1 was applied to samples of the main façade of Palmieri palace (Fig. 51) and of the north tower of the Fortress of Bashtovë (Fig. 52). They are made of ashlar and smooth limestone masonry, in the first case, and of stone and brick walls, in the second one.

The retrieved point clouds are made of millions of points (from tenths to hundreds of millions), with ground resolutions in a range of from tenth of millimetre to millimetre. In particular, image processing routines proposed in Section 5.1.1 were implemented on the two small regions of the main façade of Palazzo Palmieri indicated in Fig. 51, together with the two areas (1,2) of the north tower in Fig. 52.

As far as the fortress of Bashtovë is concerned, a particular attention was put on the north tower, because it is affected by static instabilities, visible from a huge vertical crack, as already mentioned in section 9.1.1 (Fig. 52). In first place, the tower was acquired, as part of the project “3D Impact”, for cultural and touristic dissemination purposes. But reconstructed 3D data have a sufficient resolution to accomplish also diagnostic purposes. In this light, a first phase of diagnostic analysis, based on the acquisitions of 2018, was realized (sections 9.1.1 and 9.1.2).

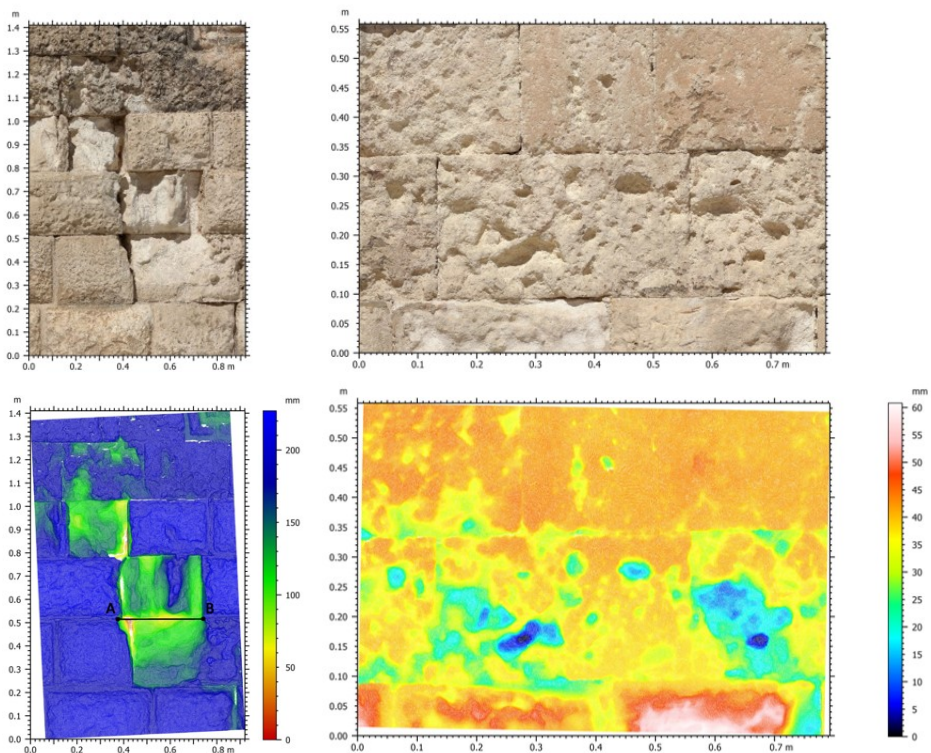
Fig. 53 - Two portions of the main façade of Palmieri Palace. Left: ashlar basement, original point cloud, false colour maps [15] [17].

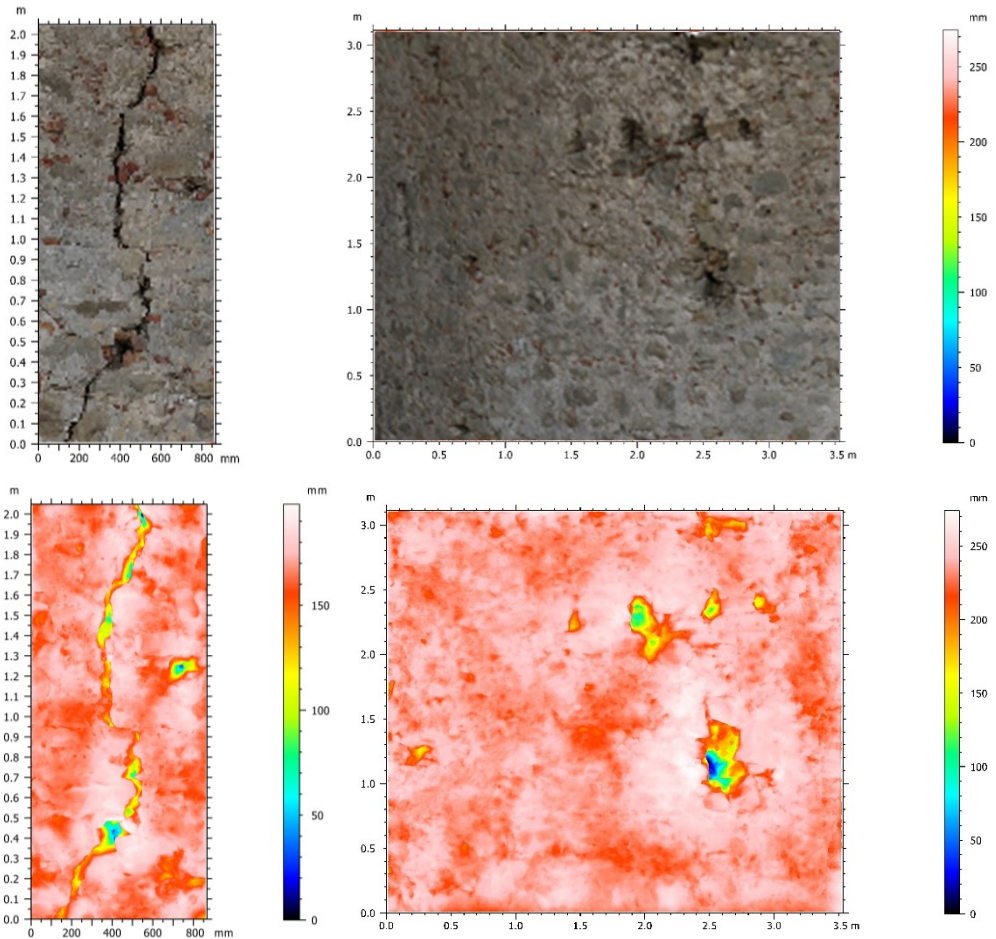
Fig. 54 – Bashtovë fortress. Two portions of the north tower: point cloud, false colour maps of the same regions [4].

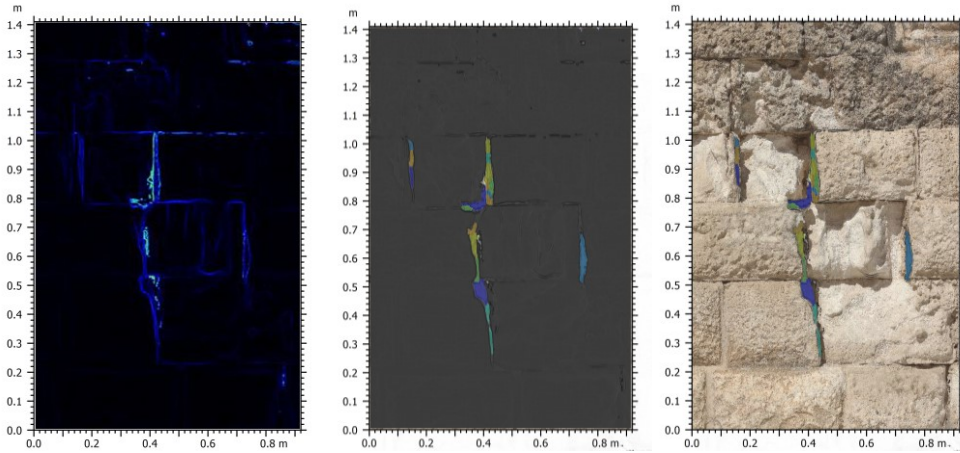
Fig. 55 – Edge extraction (gradient 9X9) and watershed segmentation, with overlapping to the original point cloud

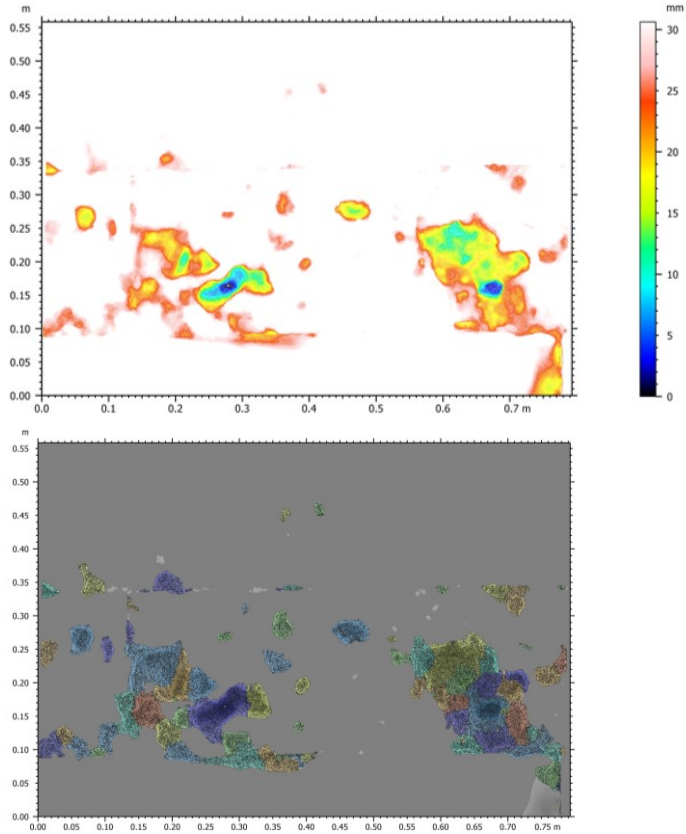
Fig. 56 – a) surface thresholding, to isolate points under threshold, most likely corresponding to defects; b) binarized surface, with the identification of grains [17]

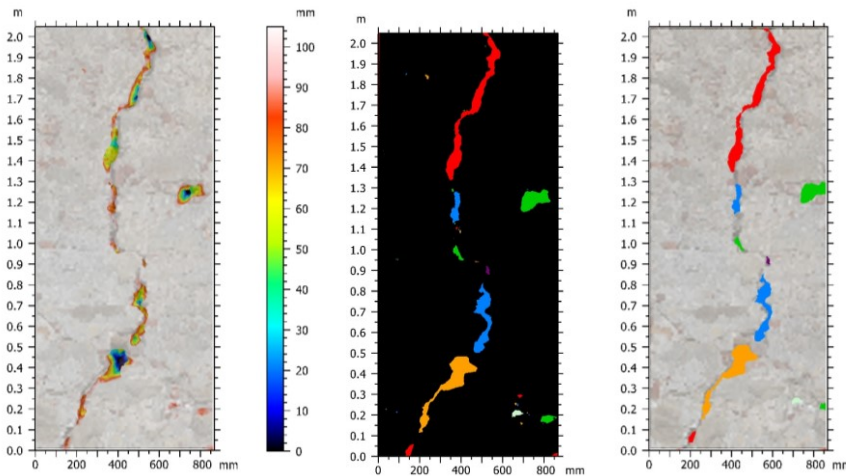
Fig. 57 – North tower, (area 1): binarized surface after the application of a depth-threshold, where the segmented regions correspond to the surface imperfections [5] [29].

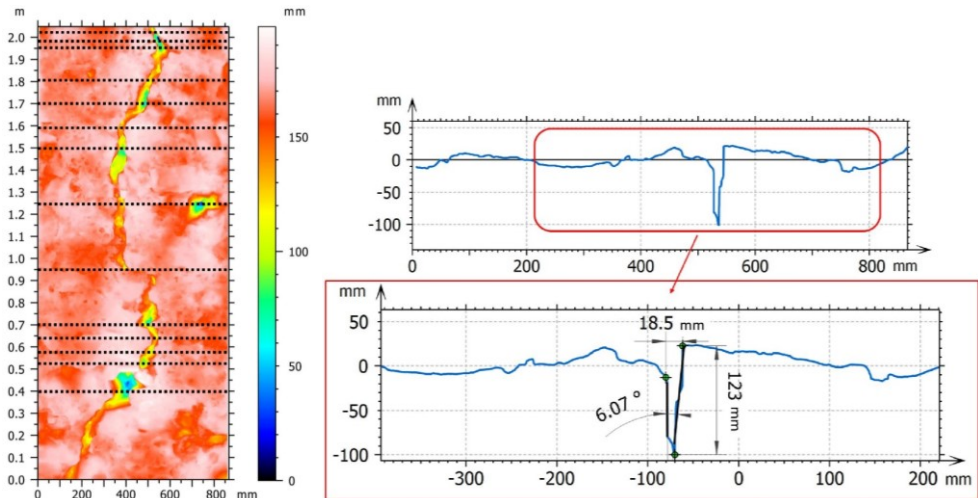
Fig. 58 - Transversal profile extracted from the surface [29].

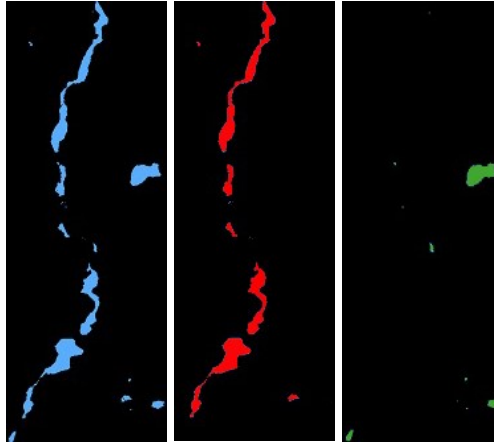
Fig. 60 - Application of a threshold value for the Form criterion, to the binarized image of Fig. 57. From left to right, original image (light blue), oblong grains (red), circular grains (green).

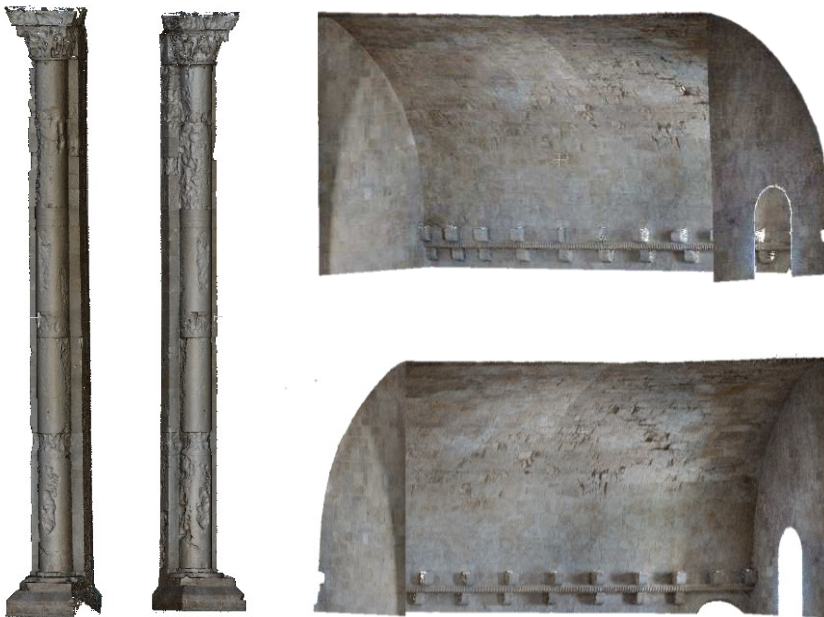
- right half-column of the interior side of the main façade (the left half column has been recently renovated with a "scuci-cuci" intervention)
- half barrel-vault of one of the lateral naves (Fig. 61).

Fig. 61 - Left: half-column; right: half barrel-vault

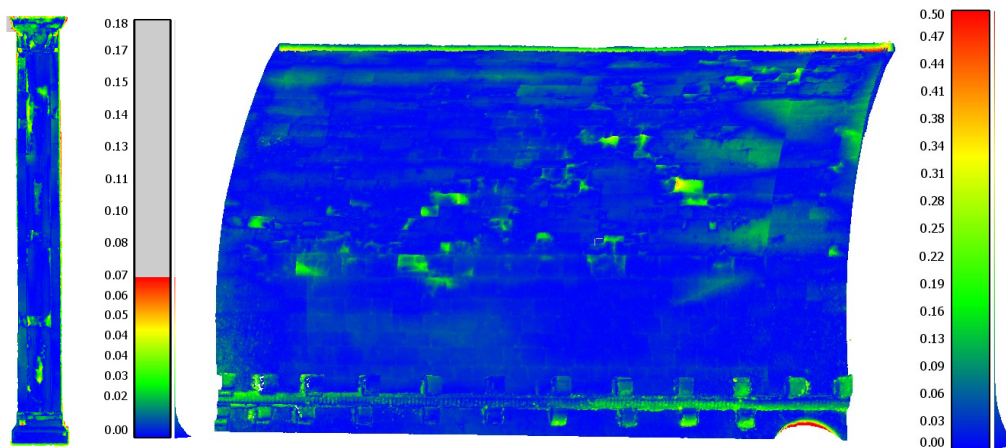
Fig. 62 – Deviation maps representing the cloud-to-cloud distance among ideal models and as-is 3D data

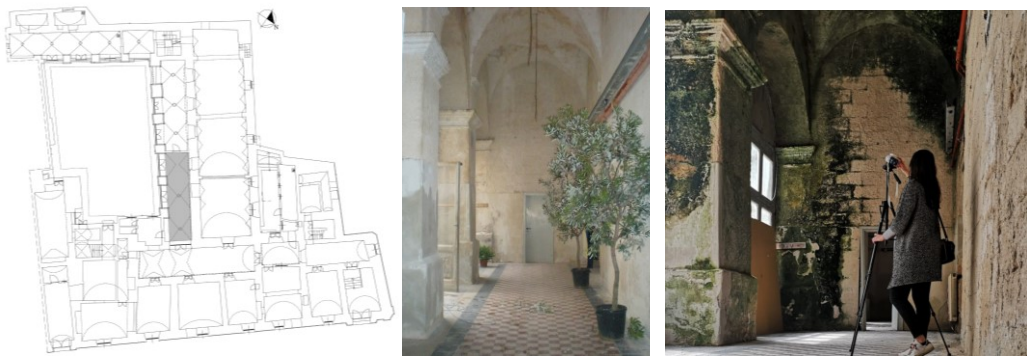
The first approach (section 5.2.1) was applied on a selected region of the main cloister of the convent of San Leonardo (Fig. 65). It is a small architectural unit, corresponding to one of the three cross-vaults of the volume adjacent to the cloister, which is covered by plaster in compromised conditions, visible from the widespread biological colonization and patina. The humidity pattern is denoted by a considerable progression over time, as it is possible to observe in Fig. 65, from the discrepancies between two photos of the cloister, taken in 2010 and 2019, respectively.

Fig. 65 - From left to right: localization of the architectural volume adjacent to the main cloister (ground floor plan), photo of the environment in 2010 and in 2019 [164]

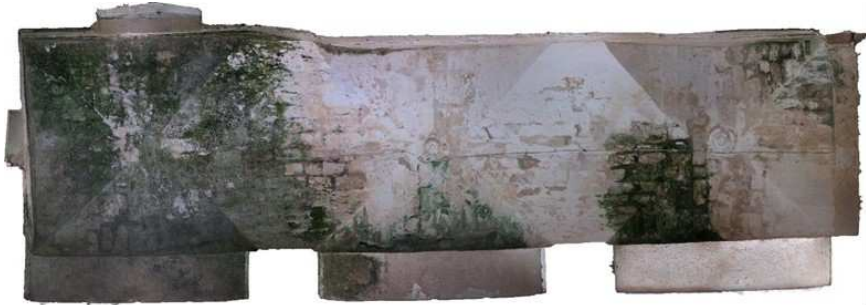
As previously explained, this process was essentially aimed at the detection of biological forms of decay, expressed within a specific colour interval, ranging from green to grey. Therefore, a preliminary routine on 2D images allowed to automatically find the proper colour range. Starting from the high-resolution orthophoto of the vault intrados, retrieved from the photogrammetric reconstruction, three values have been extrapolated, defining the limits of the interval (Fig. 66).

Fig. 66 – High-resolution orthophoto of the vault intrados

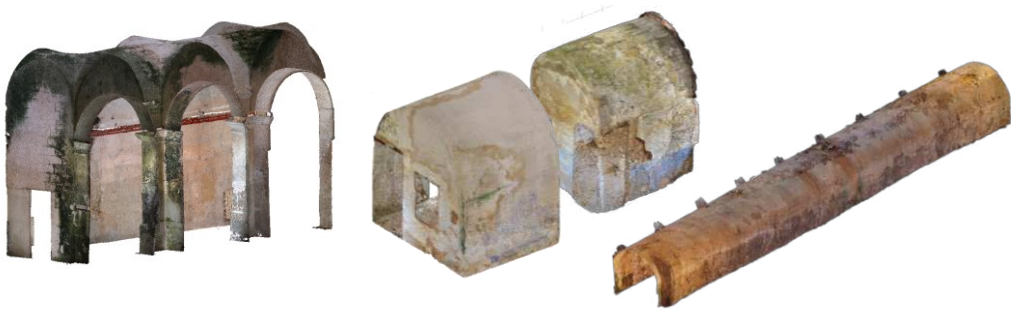
Fig. 69 – From left to right: San Leonardo, Cappuccini ex-convent, Egnazia Criptoporticus

As it is possible to observe from the photogrammetric reconstructions in Fig. 69, the three of them are characterized by an articulated three-dimensional development, plastered wall surfaces, different lighting conditions, and, most of all, extended humidity patterns, together with a variety of colour-based decay morphologies. In particular, some main classes have been considered, on the basis of the observation of the three case studies: biological patina, biological colonization, spots, deposits and moist areas, and unaltered surfaces.

The unsupervised clustering-based pipeline (sections 5.2.2 and 5.2.3), aimed at extending the field of investigation to multiple decay evidence, beyond biological patina and colonization, was applied to a plurality of case studies, in order to verify its effectiveness. Here, only three of them are proposed: the architectural volume of the main cloister of San Leonardo (with its three cross-vaults), two barrel-vaulted volumes, on the first floor of the Cappuccini ex-convent, and the south-west wing of the Criptoporticus of Egnazia. In Table 18, information about 3D reconstruction is provided.

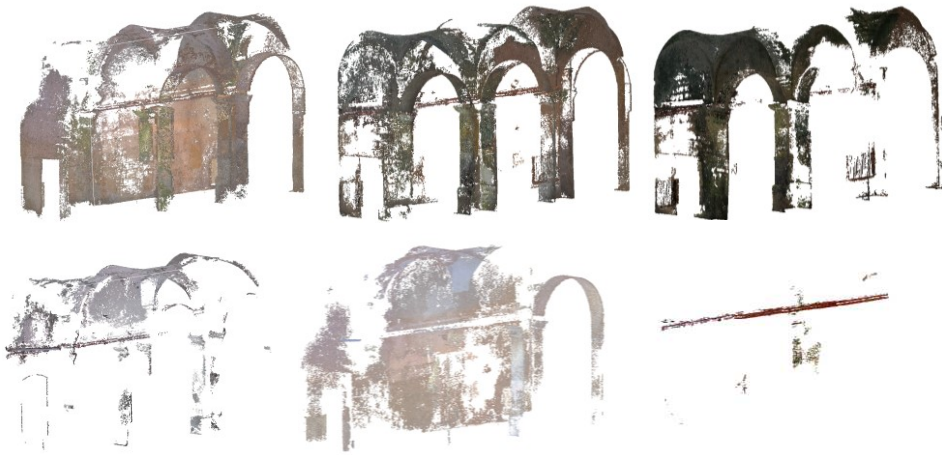
Fig. 72 – Hierarchical segmentation of San Leonardo's cloister in HSV: a) moist area (30%); b) biological patina (27%); c) biological colonization (20%); d) spots/deposit (8%); e) unaltered (11%); f) pipes (1%)

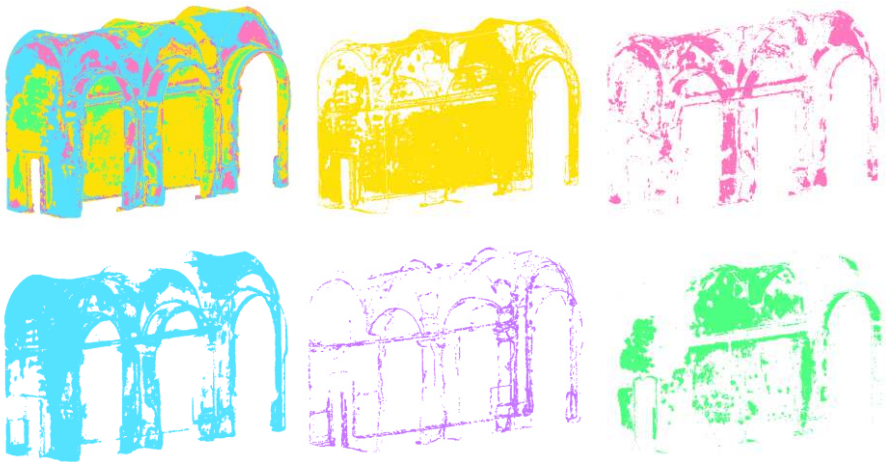
Fig. 75 – Supervised texture-based segmentation of San Leonardo's cloister: a) total classified data; b) moist area (41%); c) biological patina (9%); d) biological colonization (37%); e) spots/deposit (4%); f) unaltered (11%)

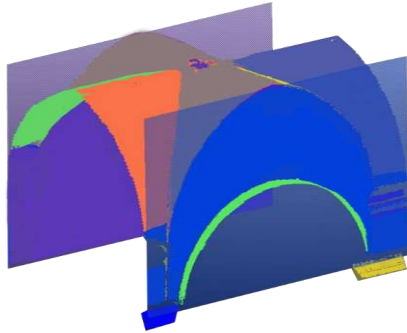
Fig. 77 - Application of the RANSAC to the point cloud of the cross vault of San Leonardo's cloister [232].

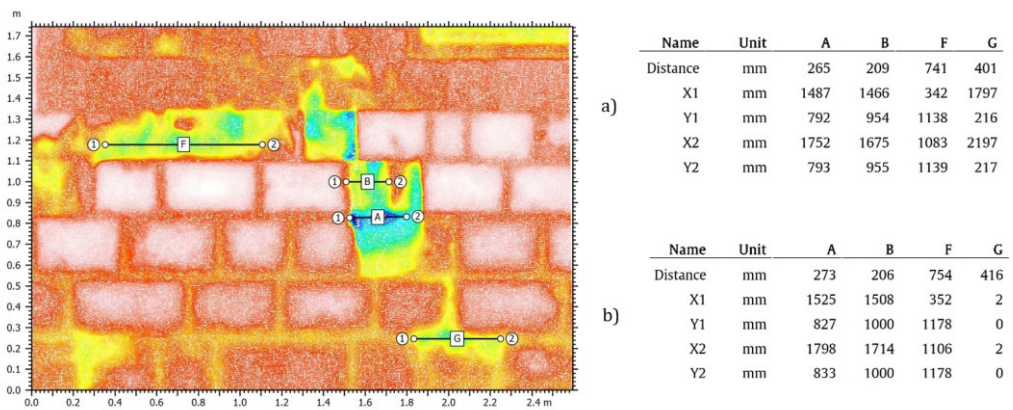
Fig. 79 Comparison between corresponding distances (A, B, F, G) in the two models: a) years 2015, b) year 2017 [4].

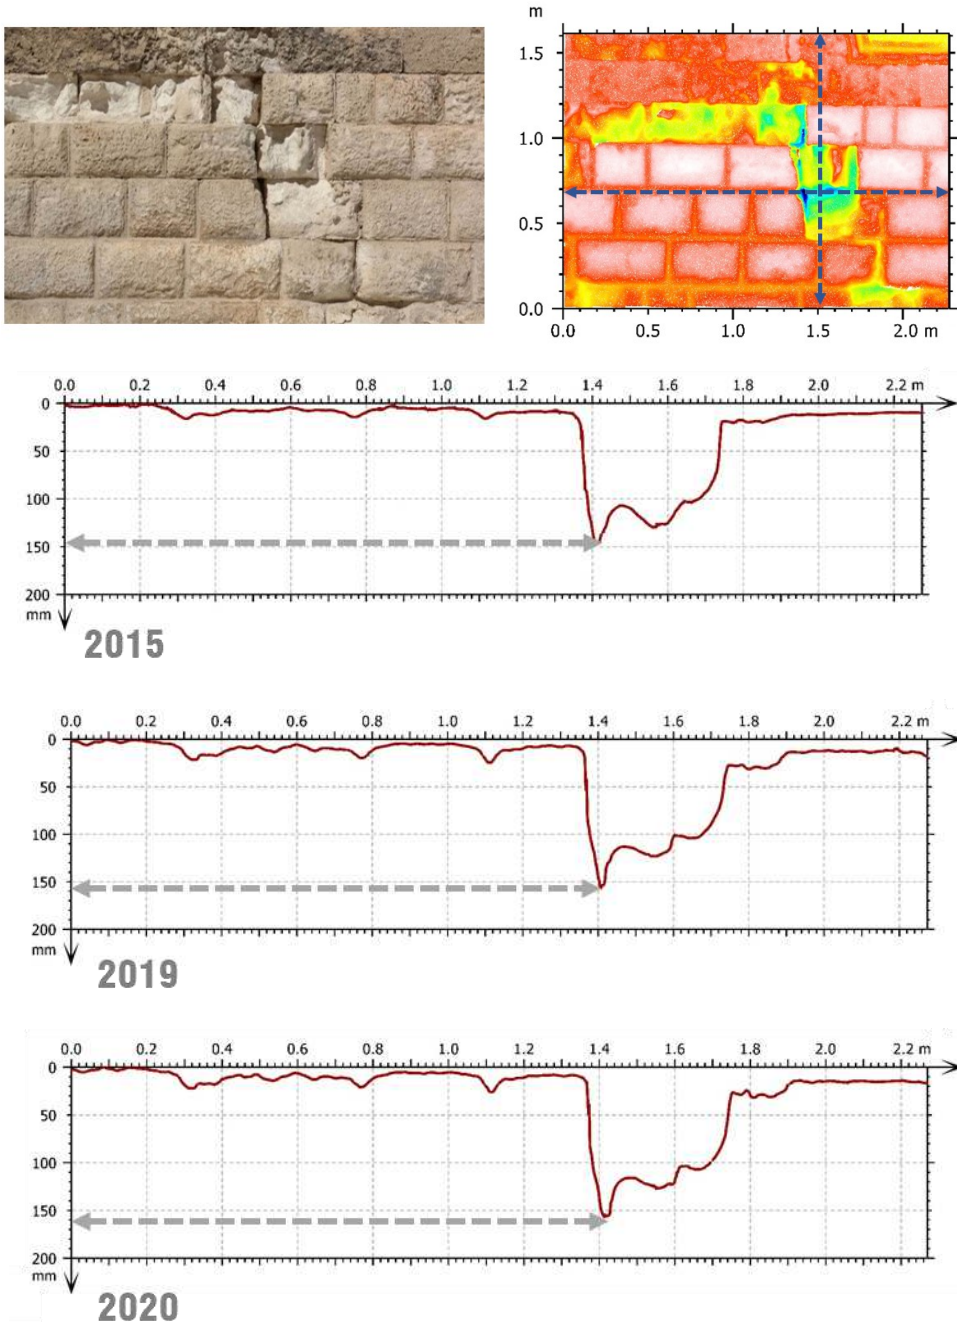
Fig. 80- Extraction of horizontal profiles passing through the deepest point, from year 2015 to year 2020.

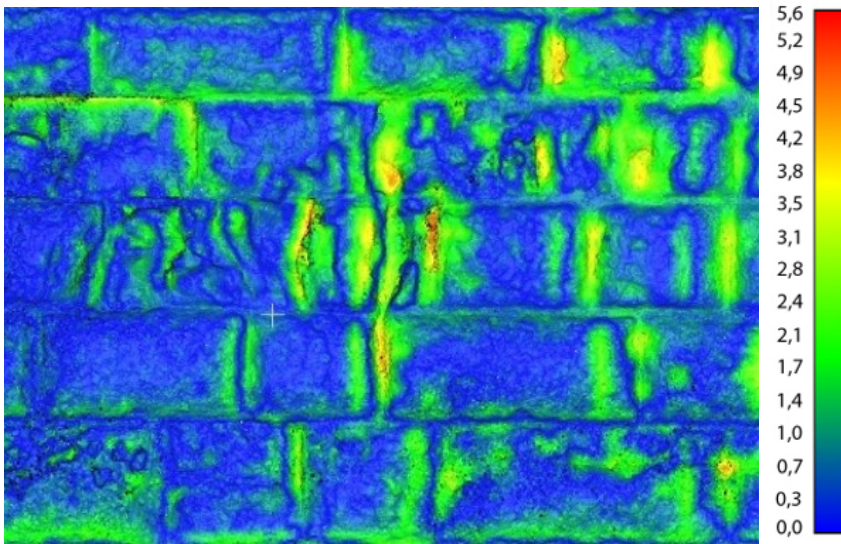
Fig. 81 – Deviation map of the restricted area of ashlar masonry, in the basement of the external façade, with absolute distances (cm) between the two point clouds (06/11/2015 - 09/06/2017)

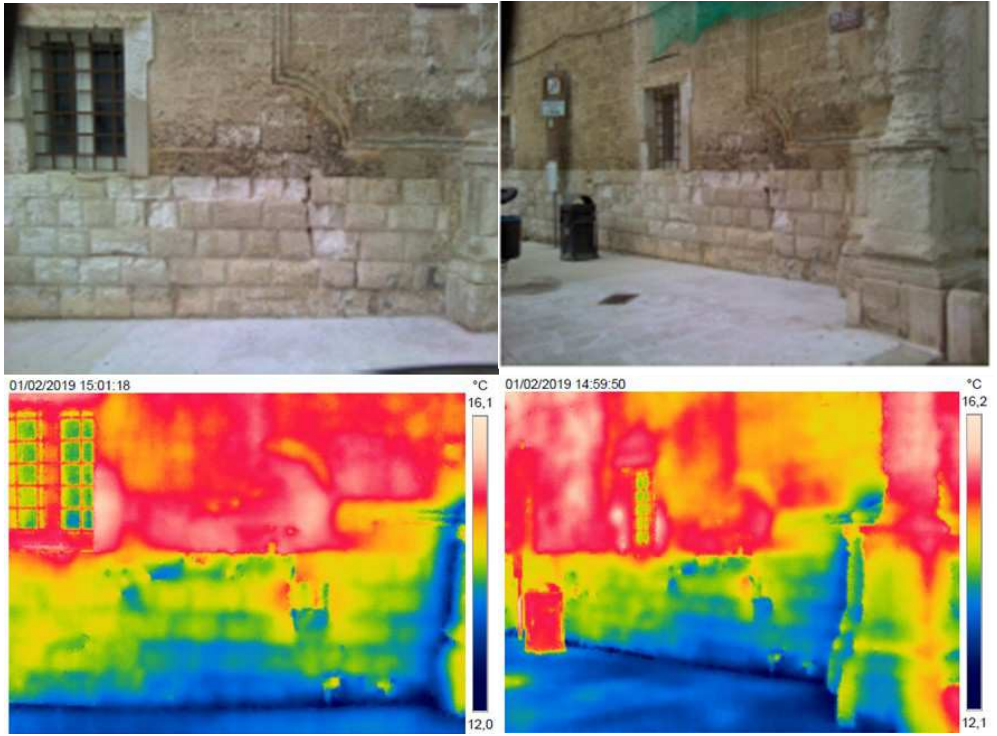
Fig. 82 – Thermographic survey, with visible and infrared representation of the same area (front and lateral view) [17]

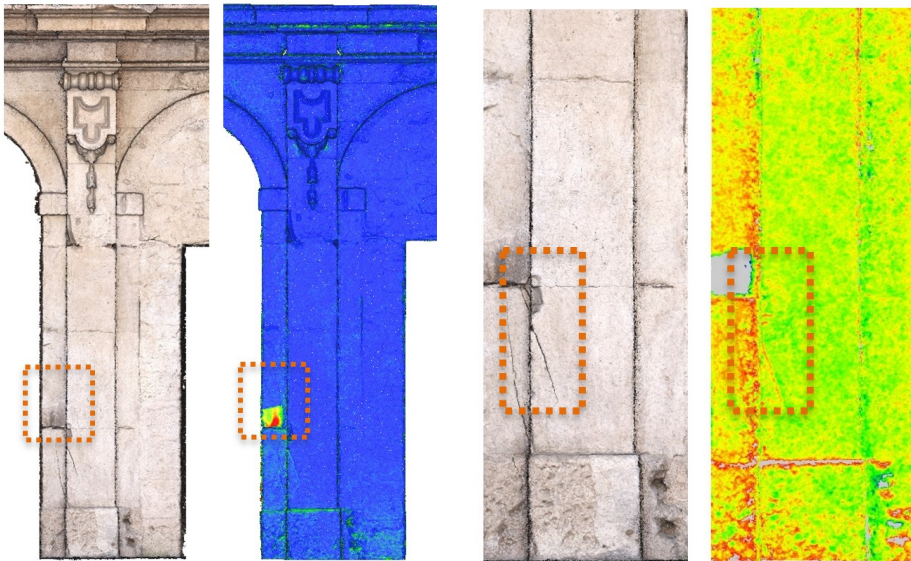
Fig. 84 - Dense point cloud of the right pillar at the ground floor level; correspondent deviation map (distances expressed in cm); zoom to observe the crack pattern [17]

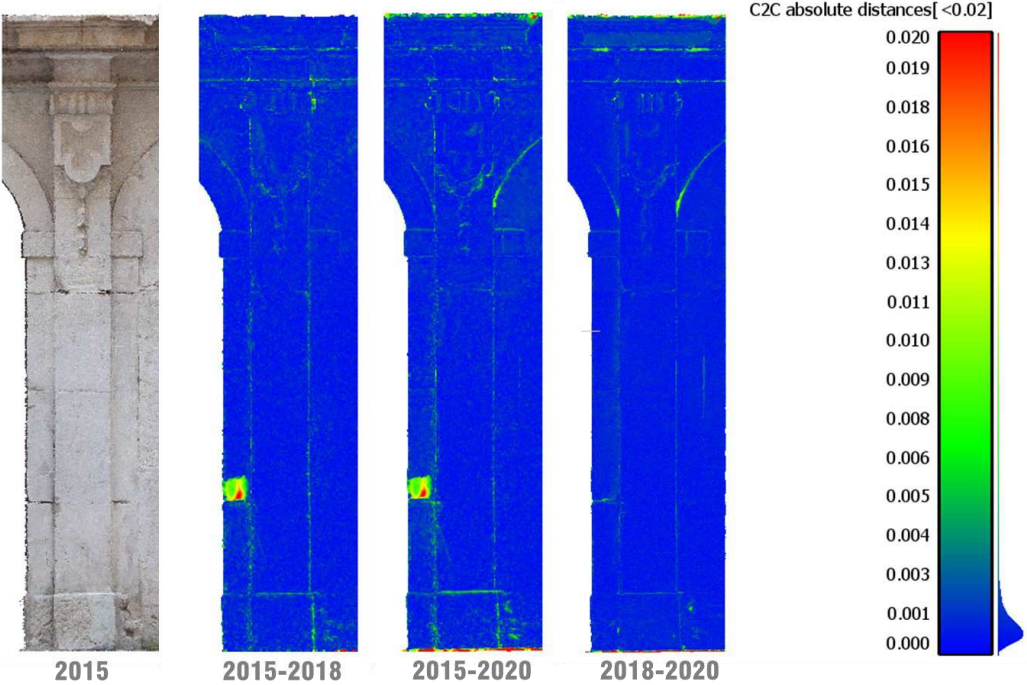
Fig. 85 – Monitoring of macroscopic alterations (lacks, cavities), resulting from the ejection of material, in consequence of the static instability (the scale of absolute distances is expressed in meters)

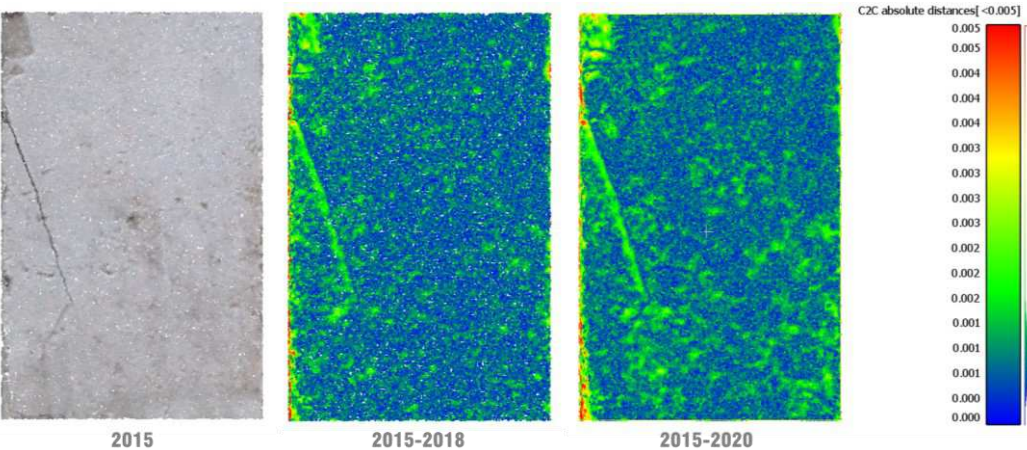
Fig. 86 – Monitoring of the crack in the right pillar (distances are expressed in metres)

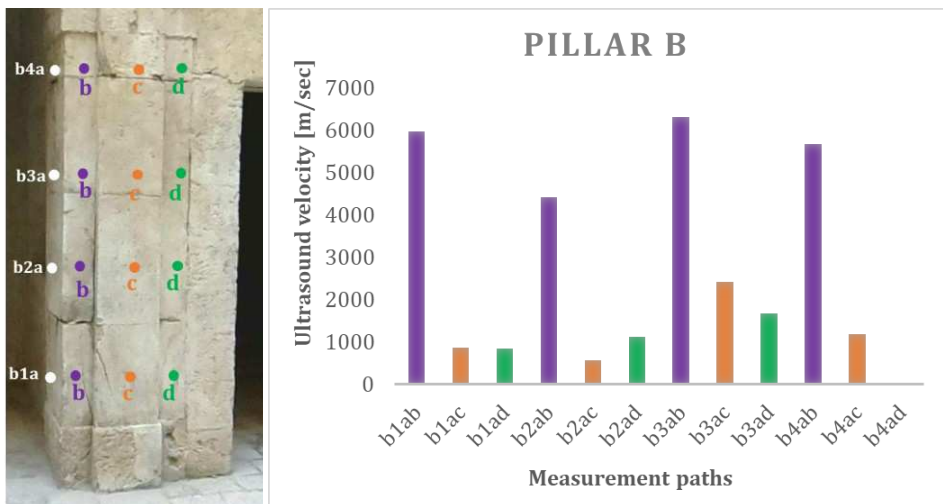
Fig. 87 - Left: ultrasonic tests scheme of the measurement paths connecting n. 4 positions of the emitter (white points) and n.12 positions of the receiver (purple, orange, green); Right: average travel velocities for each measurement path for the right pillar [17]

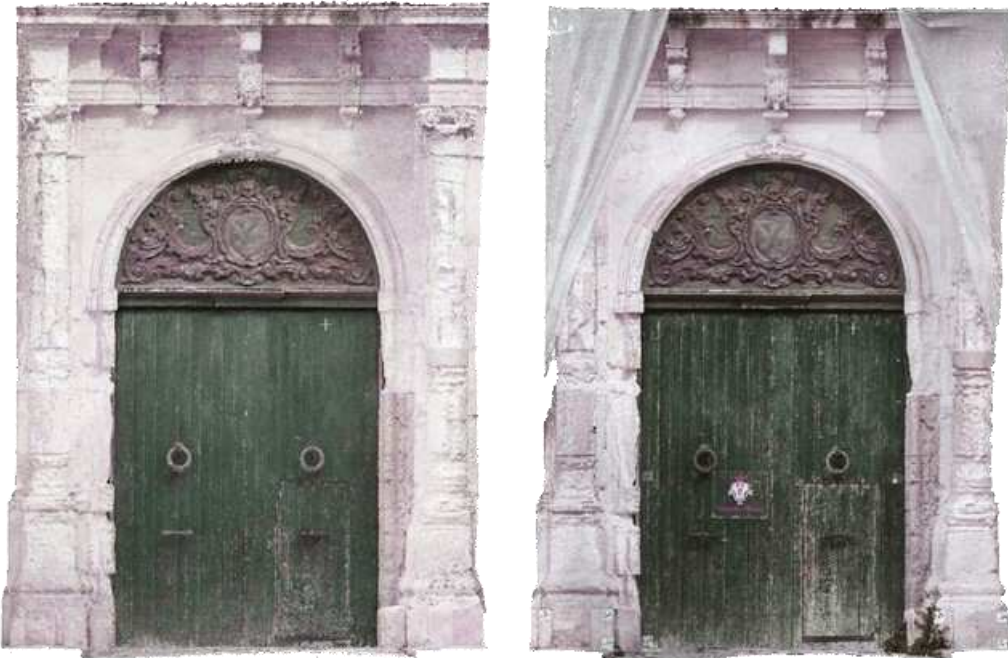
A time interval of six years, from 2015 to 2021, was considered, in order to evaluate the progression of erosion, especially in the columns and relative basements of the portal. However, it is necessary to clarify that, in the last acquisition campaign, the reconstruction was affected by the presence of protection nets, covering the upper parts of the two columns, making it impossible to confront the two capitals (Fig. 88). Partial evaluations were made on the inferior part of the portal.

Fig. 88 – Portal of the main façade. Left: point cloud of 06/11/2015; right: point cloud of 05/03/2021

The portal of the main façade of Palazzo Palmieri is consistently subjected to erosion phenomena, due to the high presence of marine salts, as a consequence of the proximity to the seaside. With this in mind, two photogrammetric acquisition campaigns were realized, as mentioned in Section 8 (Table 7).

After removing the disturbing elements, a direct comparison of the two point clouds was accomplished, with 3-points and ICP registration, and, then the computation of the models' deviation. The registration of the two models was affected by the presence of
