POLITECNICO DI BARI

Doctor of Philosophy in Environmental and Building Risk and Development

**Innovative methods and techniques for diagnostics and monitoring of architectural heritage, through digital image processing and machine learning approaches**

Cover image: elaborated 3D model of the north tower, Bashtova Fortress (Albania)

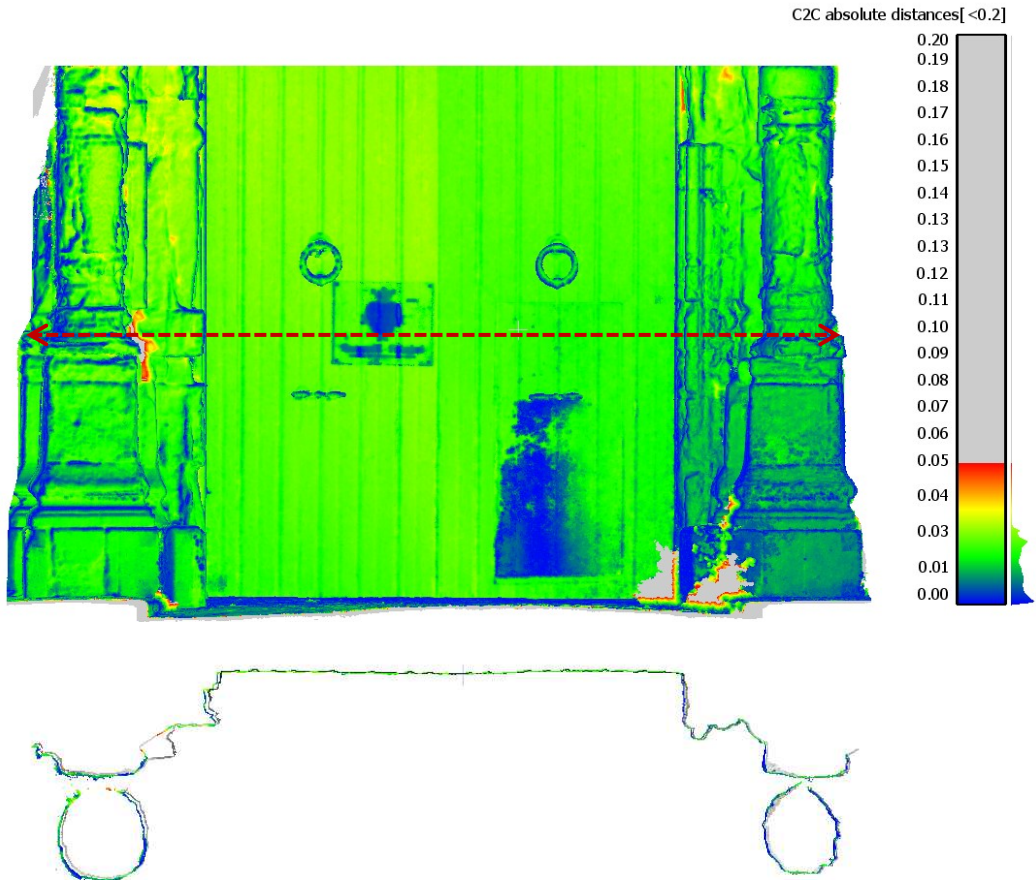
Fig. 89 - Deviation map of the bottom part of the portal, with corresponding transversal sections (scalar field expressed in metres)

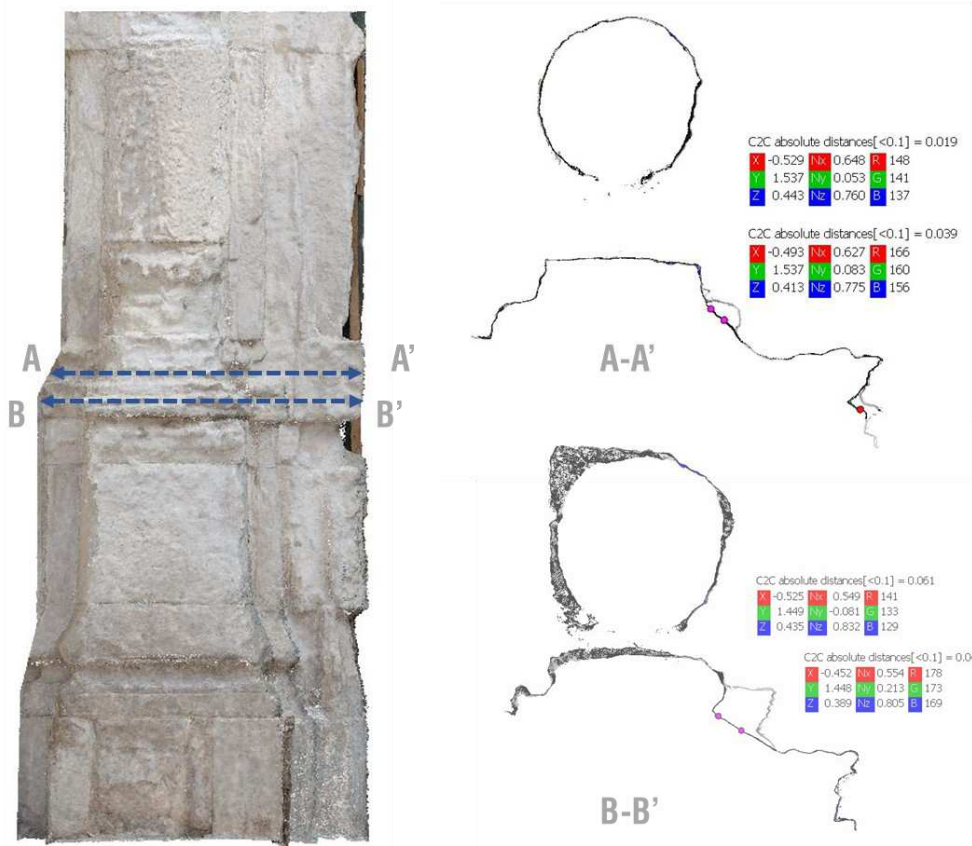
Fig. 92 – Cross-sections extracted from the left column base

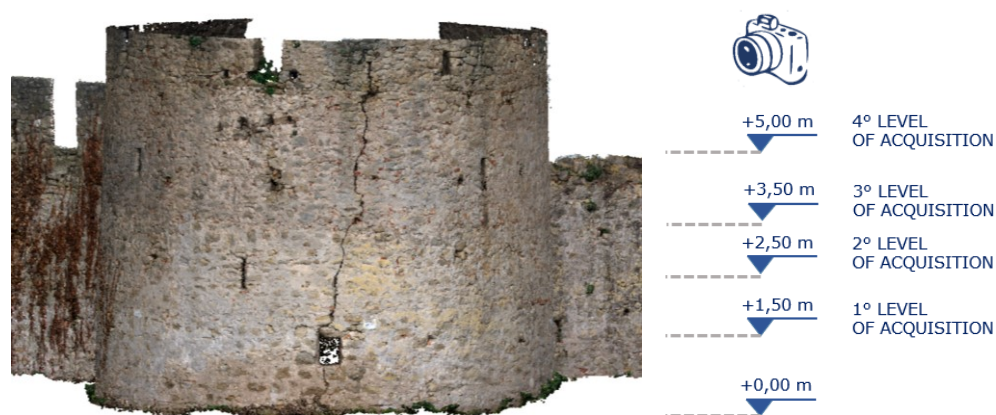
Fig. 93 – Point cloud of the north-tower, with the indication of the points of the four heights of acquisition

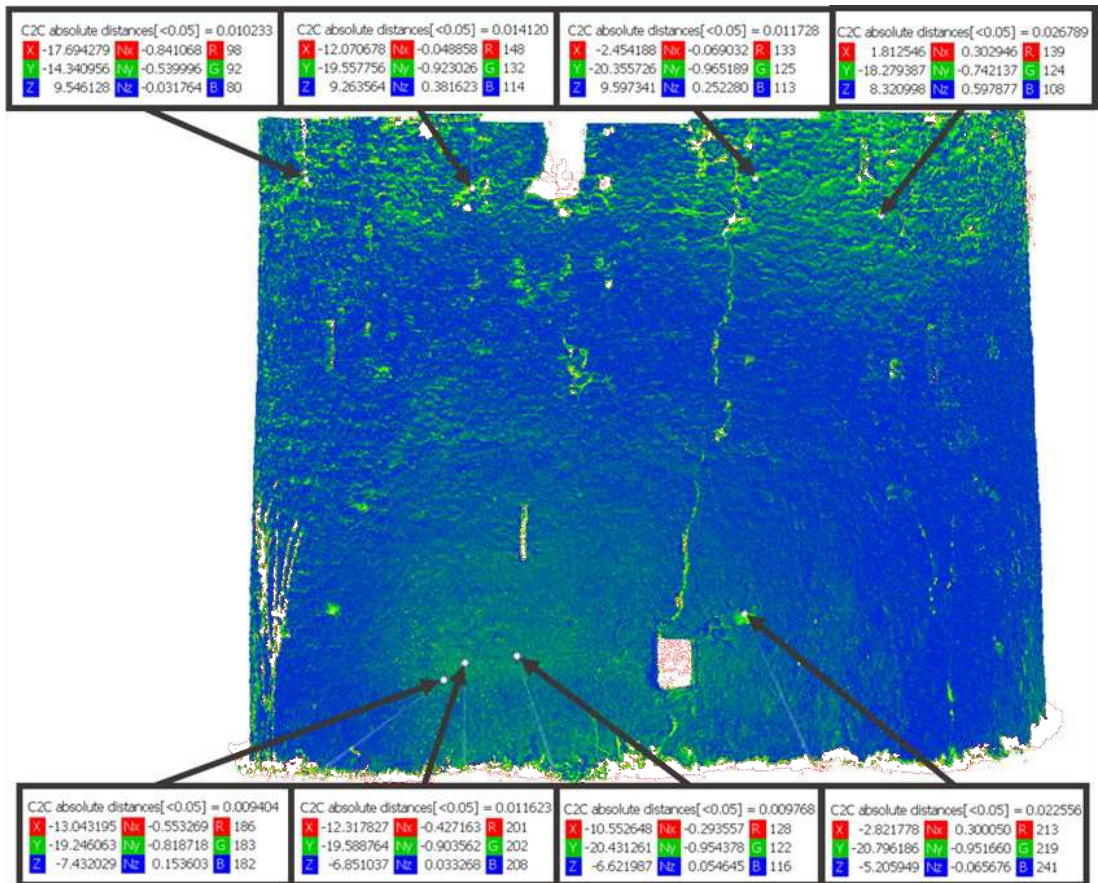
Fig. 94 - Deviation map of the north tower, after the direct comparison of point clouds of 2018 and 2020 point

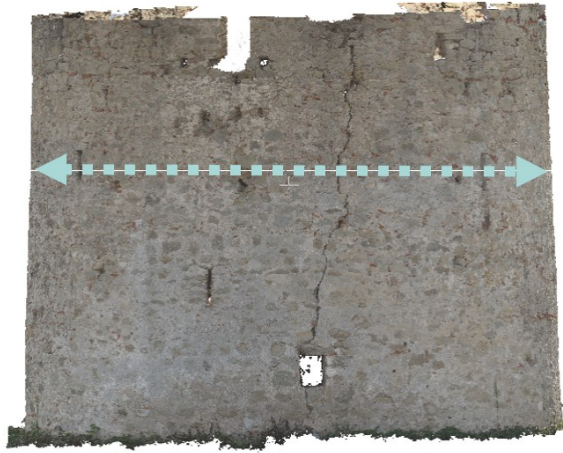
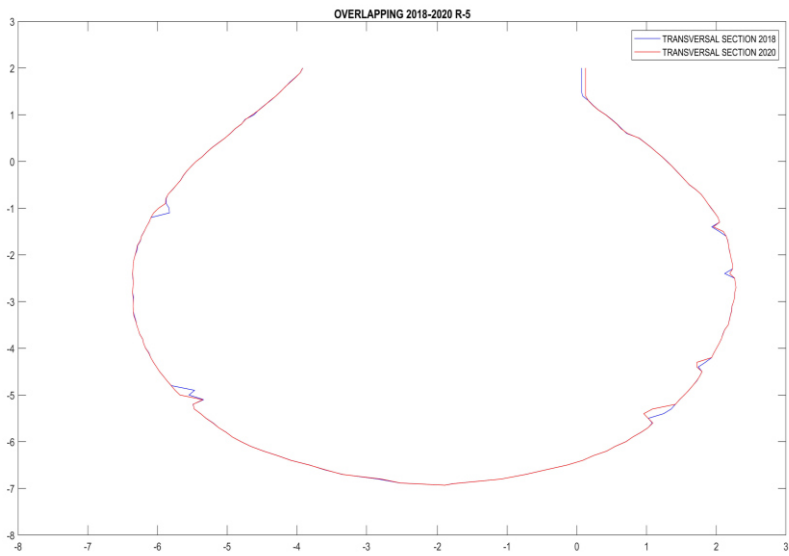
Fig. 96 – Example of transversal profile extraction and comparison
