### Administrative unit: University of Padova

# LARGE INFREQUENT DISTURBANCES (LIDS) ON MOUNTAIN BASINS: PRIMARY AND CASCADING MORPHOLOGICAL AND SEDIMENTOLOGICAL RESPONSES

Supervisor: Prof. Lorenzo Picco

PhD candidate: Giacomo Pellegrini

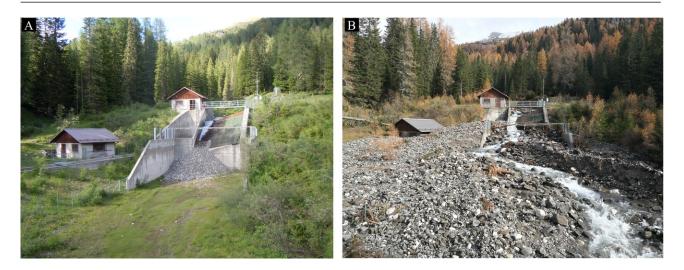
Figure 2.6 Bedload storage area (A) pre- and (B) post-October 2018 flood.
